**CIVIL AIRCRAFT ACCIDENT No. CAV/ACC/6/22**

**FINAL REPORT ON THE ACCIDENT TO ATR 42-500 AIRCRAFT REGISTRATION**  
**5H-PWF WHICH OCCURRED ON 6 NOVEMBER 2022 IN LAKE VICTORIA NEAR BUKOBA AIRPORT**

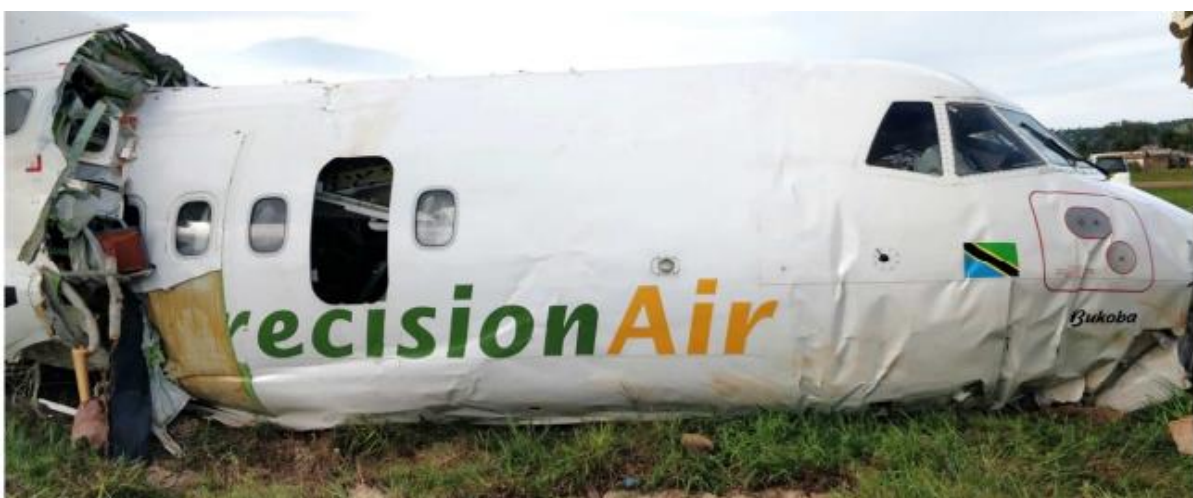
The nose and forward fuselage sections were significantly damaged whereas the aft section suffered minor damage. The radome was found completely separated from the fuselage.

The frame 1 bulkhead, the stiffeners and the Nose Landing Gear (NLG) bay were found severely deformed, buckled and fractured, consistent with heavy impact damage. The underneath section of the fuselage was significantly damaged, deformed and detached with broken belly fairing panels. Also wrinkled frames and aircraft skin were detached from the fuselage.

The floor panels and associated structures were heavily damaged. The skin was completely torn and the fuselage was almost separated between frame number 13 and 23.

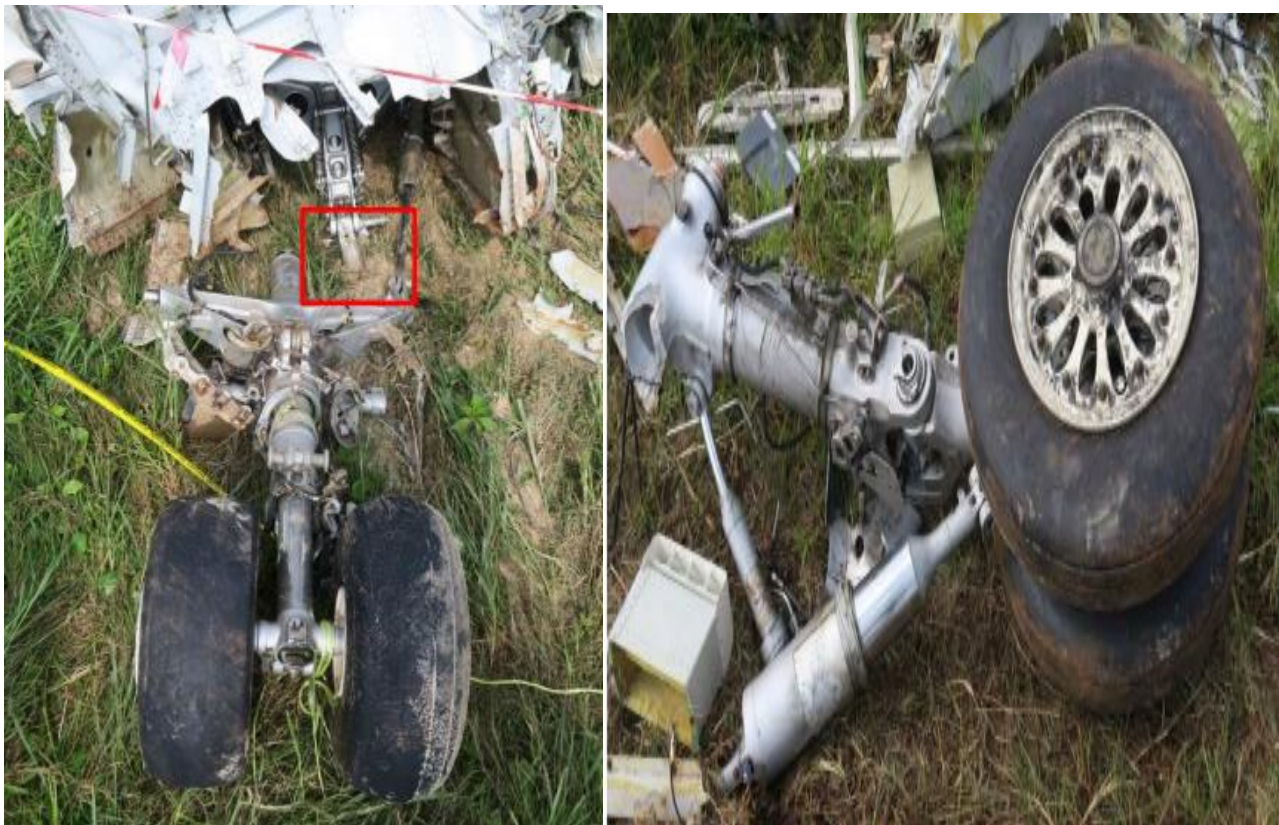
The right hand Main Landing Gear was found in extended position and still attached to the aircraft structure. The left Main Landing Gear was found separated from the aircraft, fractured at the middle of the upper leg and a deformed extension/retraction actuator.

The Nose Landing Gear assembly was separated from its main fittings but still attached to the actuator link. The connection with the drag brace was broken.

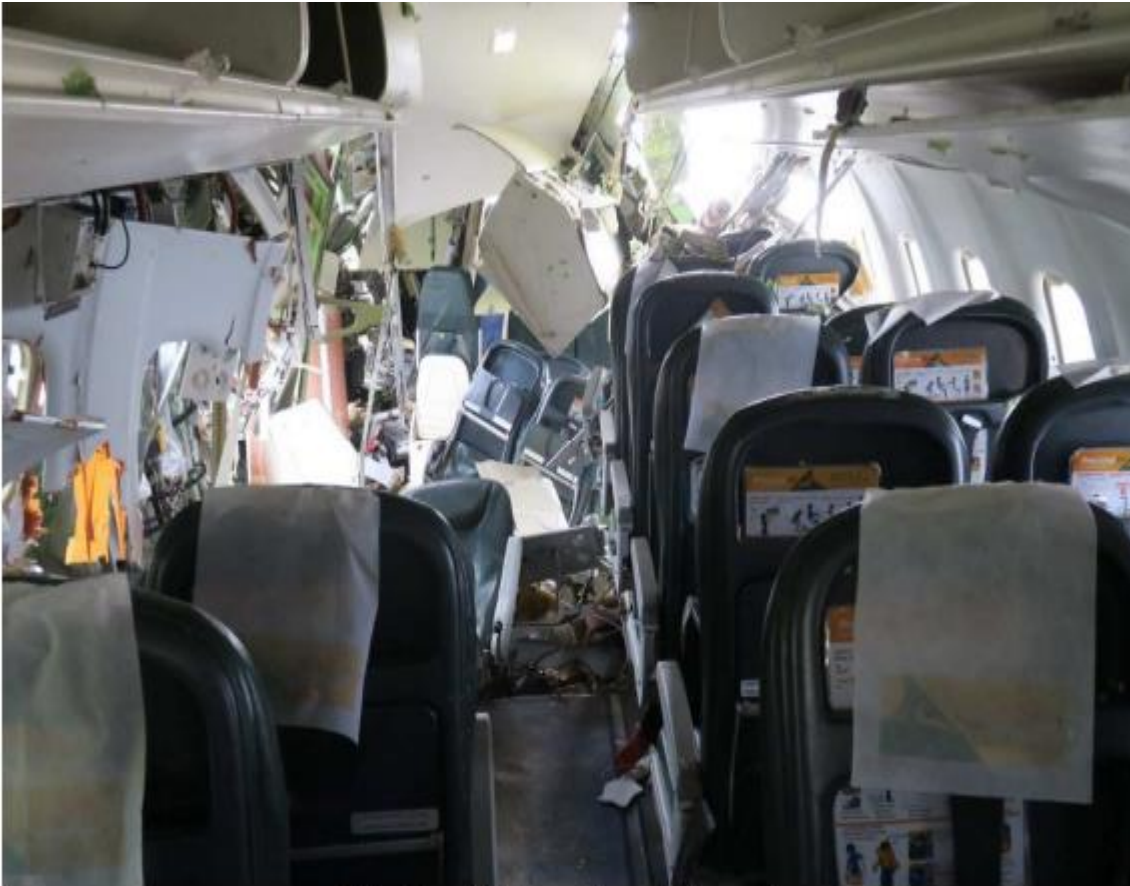
Cabin floor from seat row number 7 forward was significantly damaged, distorted and several passengers seats were partially or completely detached consistent with high energy impact with water.

Forward cabin crew seat was in place but the aft cabin crew seat had been completely detached from the floor and was found outside the wreckage.
