**CIVIL AIRCRAFT ACCIDENT No. CAV/ACC/6/22**

**FINAL REPORT ON THE ACCIDENT TO ATR 42-500 AIRCRAFT REGISTRATION**  
**5H-PWF WHICH OCCURRED ON 6 NOVEMBER 2022 IN LAKE VICTORIA NEAR BUKOBA AIRPORT**

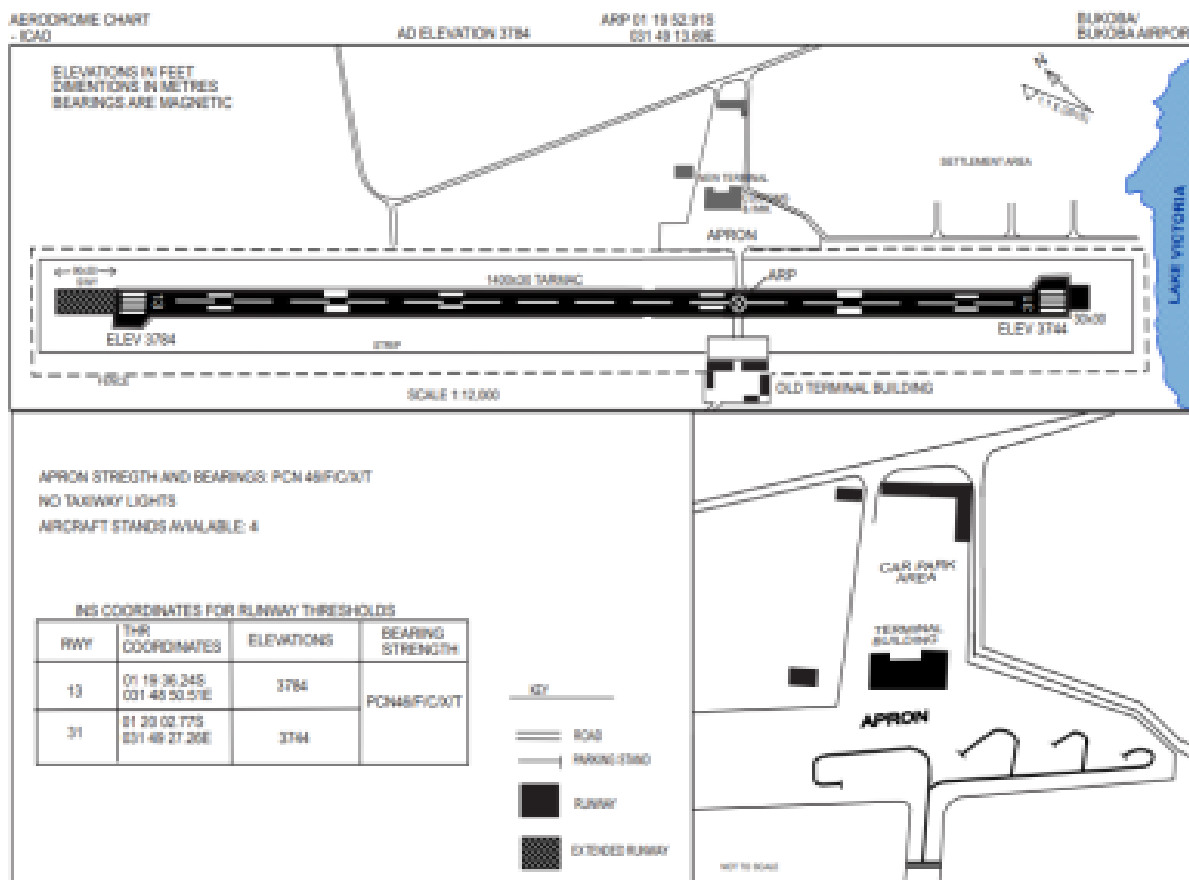
## Bukoba Airport

Pilots who frequently fly into Bukoba reported that the approach to the airport can be tricky in adverse weather conditions. The runway is short with obstacles in both directions. There is Musila Island with a 36 meters tall cliff located 2.8 km away along the path to the threshold of runway 31. There are also tall hills rising to 560 feet above the elevation of the airport in the approach path of runway 13. During rainy season at Bukoba it is usual to experience abrupt changes in weather conditions, sometimes lasting a good fraction of an hour which creates severe turbulence above the lake surface especially near the shores. Wind shear has also been reported by pilots flying into this airport.

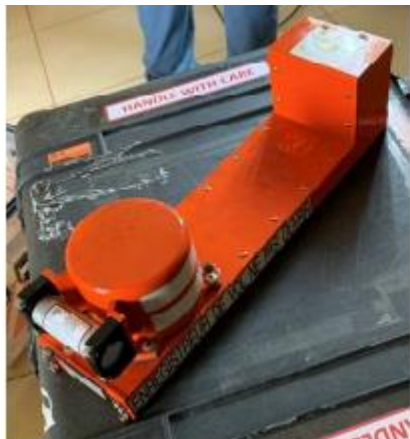
**CVR**

1.10.1 The Aircraft was equipped with a Cockpit Voice Recorder (CVR) and a Flight Data Recorder (DFDR) as required by the current Civil Aviation (Instruments and Equipment) regulations. At the time of the occurrence both recorders were serviceable.

Both recorders were recovered from the wreckage and examined at the BEA, Le Bourget, France. Downloading and analysis was performed by the experts from BEA with the presence of the Tanzania AAIB investigation team.
